# PROPERTY INSPECTION REPORT

**Prepared For:** Client's Name Here  
(Name of Client)

**Concerning:** Property Address Here  
(Address or Other Identification of Inspected Property)

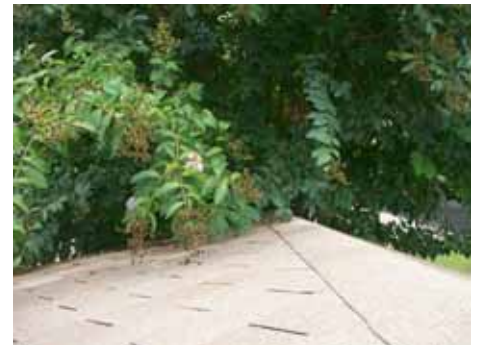
- The roof covering over the carport area is in poor condition and is leaking. The roofing material will need to be replaced.
- The roofing material observed to have impact damage in various locations. The impact damage may have been caused by a previous hailstorm and should be further evaluated.
- Roof fasteners (nails and/or staples) observed to be exposed and should be properly sealed at the ridge caps and flashing areas.
- Damaged shingle tabs were observed on the north, east and south sides of the roof structure.
- High shingle fasteners (staples and/or nails) observed in various locations.
- Some discoloration of the roofing material was observed at the time of this inspection.
- There are some defects and/or raised spots in the roofing material on the north side of the roof structure.

You are strongly encouraged to have your Insurance Company and/or properly certified roofing contractor to physically inspect the roof, *prior to closing*, to fully evaluate the insurability and condition of the roofing material. The observation made to support the rendering of this opinion are listed but not limited to the following:

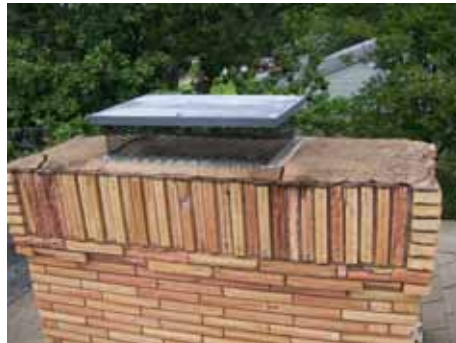
- Caulking improvements are recommended for the area between the exterior veneer and the window frames.
- The wood veneer has some deterioration and/or damage on the west side of the house.
- The roof level chimney structures brick veneer has some deterioration and/or damaged.
